Metallurgical Analysis of Railgun Material

¹Materials Science and Technology Division, ²Plasma Physics Division
Naval Research Laboratory, 4555 Overlook Ave., SW, Washington, DC 20375, USA

Abstract— The effect of number of shots on multiple launch railgun barrel material performance under significantly high current conditions was studied. Metallurgical analysis was conducted on rail samples from four sets of experiments involving increasing number of shots. Cross-sections of samples from two locations in the copper rail were examined using a variety of metallographic techniques. During each shot a thin film of molten aluminum from the armature deposited on the rail surface. The deposit became thicker and multi-layered with increasing number of shots and was consistently thicker in the bottom half of the vertically oriented rails than in the top half. Preferential removal of material occurred along the rail edges, which resulted in grooving over the length of the rails. Grooves were consistently deeper near the top edge of the rails compared to the bottom edge. A proposed mechanism for grooving is dissolution of the rail material into molten aluminum flowing towards rail interior

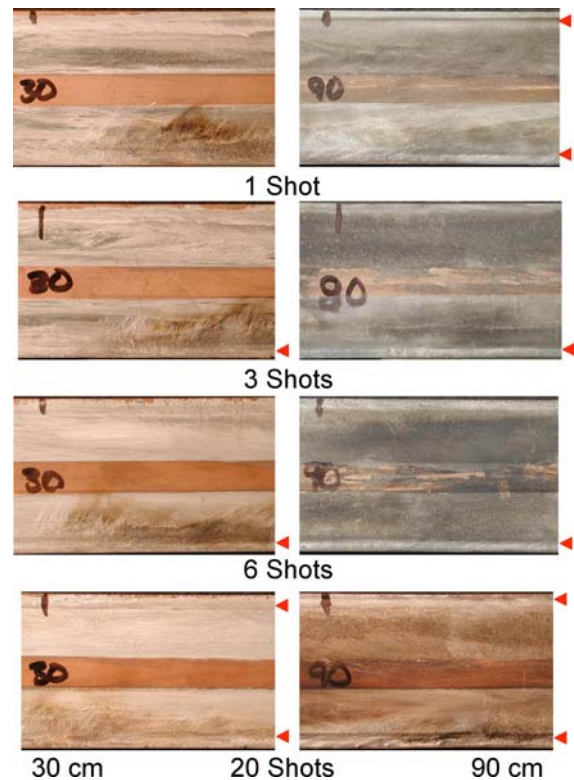
The appearance of the surfaces of the 30-36 cm and 90-96 cm copper rail segments after each of the four experiments is shown in Fig. 1. In these pictures the armature is moving from left to right and the top edge of the rail is at the bottom. The solidified aluminum deposit appears as a silvery coating on the rail

Fig. 1. Photographs of 30-36 cm and 90-96 cm copper rail sections showing appearance of rail surfaces. Arrowheads point to grooves near rail edges. (In these pictures, the armature is moving from left to right and the top edge of the rail is at the bottom.)

surface on either side for a bare central track. Flow patterns on the deposit show that the liquid film flow direction is from rail edge to rail interior. Some of the aluminum also appears to have flowed over the rail edges. In most sections, grooves (marked by arrowheads) are visible close to both rail edges. Grooving is localized removal or “erosion” of material from the rail surface and usually spans the length of the rail.

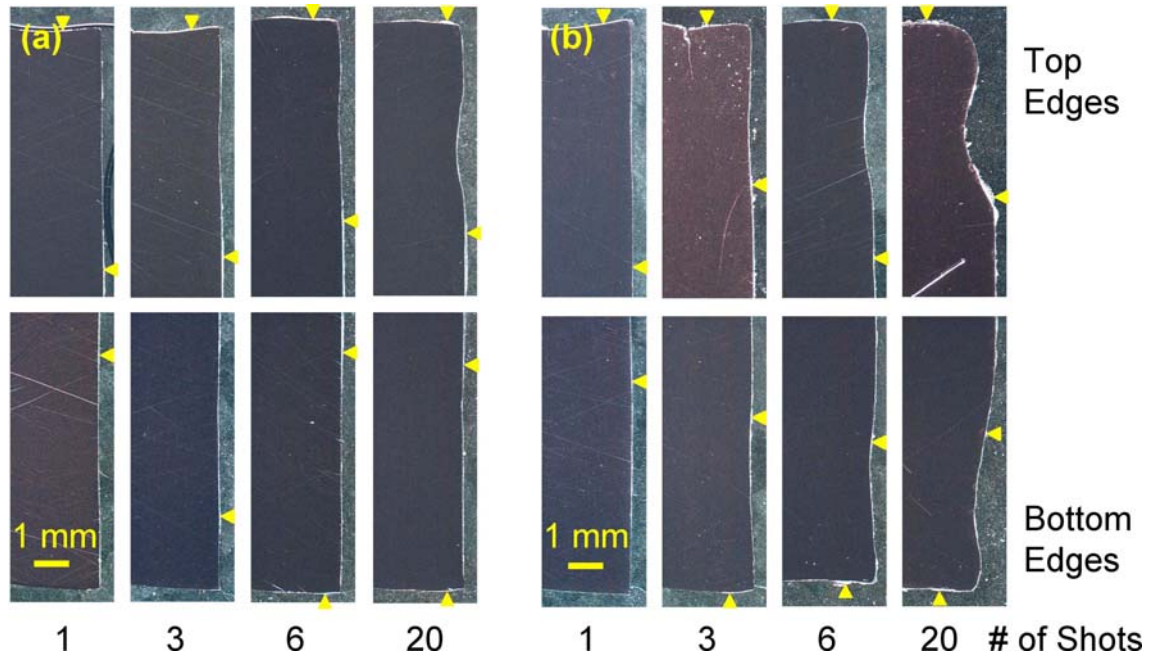
Fig. 2. Optical photomicrographs (Mag=20x) showing cross-sections near the top and bottom edges of the rails as a function of number of shots. (a) 36 cm sections. (b) 94 cm sections.

Optical photomicrographs of cross-sections near both rail edges are shown in Fig. 2. The thin silvery film (marked by arrowheads) along the edges of the cross-sections is the thin aluminum deposit. Using the relatively flat middle section of the rail surface as a reference point, groove depths were measured and the results are plotted in Fig. 3. Linear increasing trends in groove depth with increase in number of shots are evident. Grooves are 4 to 6 times deeper in the 94 cm samples than in the 36 cm samples. They are 1.5 to 2 times deeper in the top edge of both sets of samples than in the bottom edge. In the 94 cm samples, the increase in groove depth is proportional to the increase in number of shots, i.e., doubling the number of shots doubles groove depth. In the 36 cm samples, the increase in groove depth is not proportional to the increase in number of shots, i.e., doubling the number of shots increases the groove depth by less, 1.33 times. Using the deepest point in the groove, its location was measured from the rail edge and the results are

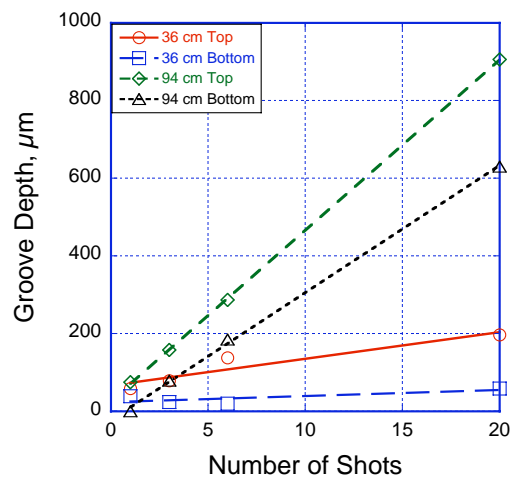
Fig. 3. Graph showing plots of groove depth as a function of number of shots.

Measurements show that doubling the number of shots doubles groove depth in the 94 cm samples, which is a strong cumulative effect. The same is not true for the 36 cm samples probably due to the transient nature of the grooving process early in the shot. There is variability in the groove position relative to rail edge from top to bottom of the rails and from the 36 cm section to the 94 cm section. This may be due to variability in armature starting positions, uneven armature deterioration or asymmetry in contact. The observed asymmetry in deposit thickness and groove depth across the rails is most likely a result of uneven gap formation between the armature and rail. It is well known that due to magnetic interactions with the steel support structure, there is an imbalance in forces and the armature tends to ride higher or closer to the top edge of the rail. This is confirmed by measurements of groove positions at 36 cm, which show that the top groove is closer to the edge and the bottom groove is farther from the edge.

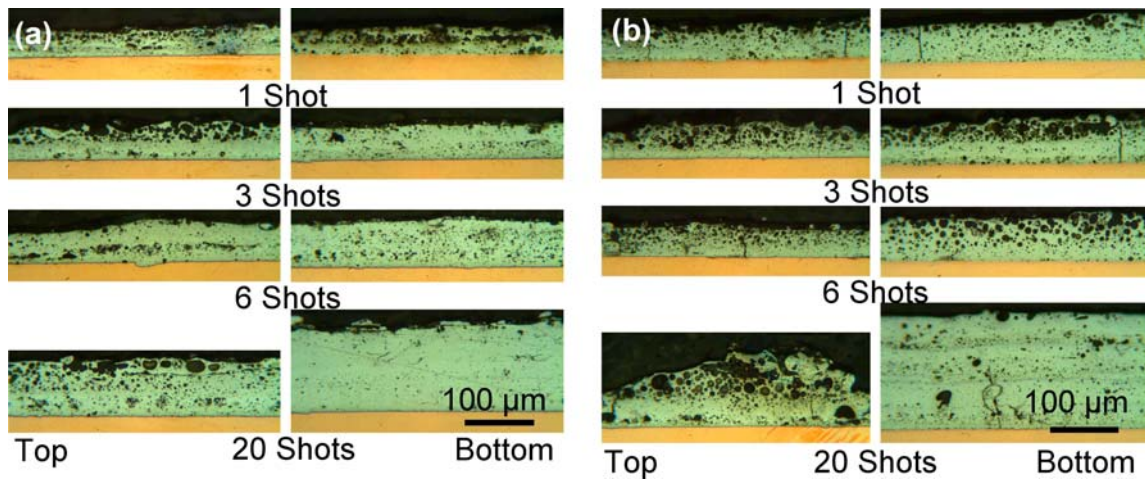
Fig. 4. Optical micrographs showing cross-sectional view of aluminum deposit in top and bottom halves of the copper rails as a function of number of shots. (a) 36 cm sections. (b) 94 cm sections.

Optical micrographs showing aluminum deposit thickness and multi-layering are given in Fig. 4. Multi-layers are defined by distinct interfaces. Micrographs are from the thickest portion in the deposit, which was typically halfway between the rail edge and rail axis. The thickness of the deposit and number of layers increase with increase in number of shots. However, the number of observed layers are much less than the number of shots. The deposit is thicker in the bottom half of the rails than in the top half. The average thickness of the deposit was measured and results are plotted in Fig. 5(a). Linear increasing trends between deposit thickness and number of shots are observed. However, the increase in thickness is not proportional to number of shots, i.e., doubling the number of shots increases thickness by 1.25 to 1.60 times. Also, thickness increases at a greater rate in the bottom half compared to the top half of both sets of

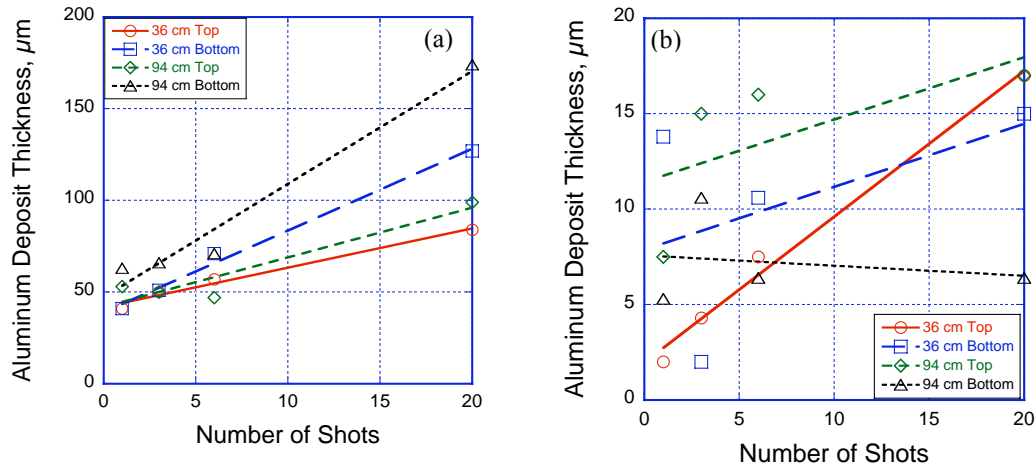
samples. The thickness of the residual deposit in the groove was also measured and the results are plotted in Fig. 5(b). The groove deposit is thin, varying from 2 and 17 μm . Except for the linear trend in the 36 cm top sections, the rest of the data shows random scatter and a lack of any trend in the groove deposit thickness with number of shots.

Fig. 5. Graphs showing plots of aluminum deposit thickness as a function of number of shots. (a) Thickest portion of deposit. (b) Deposit in groove.

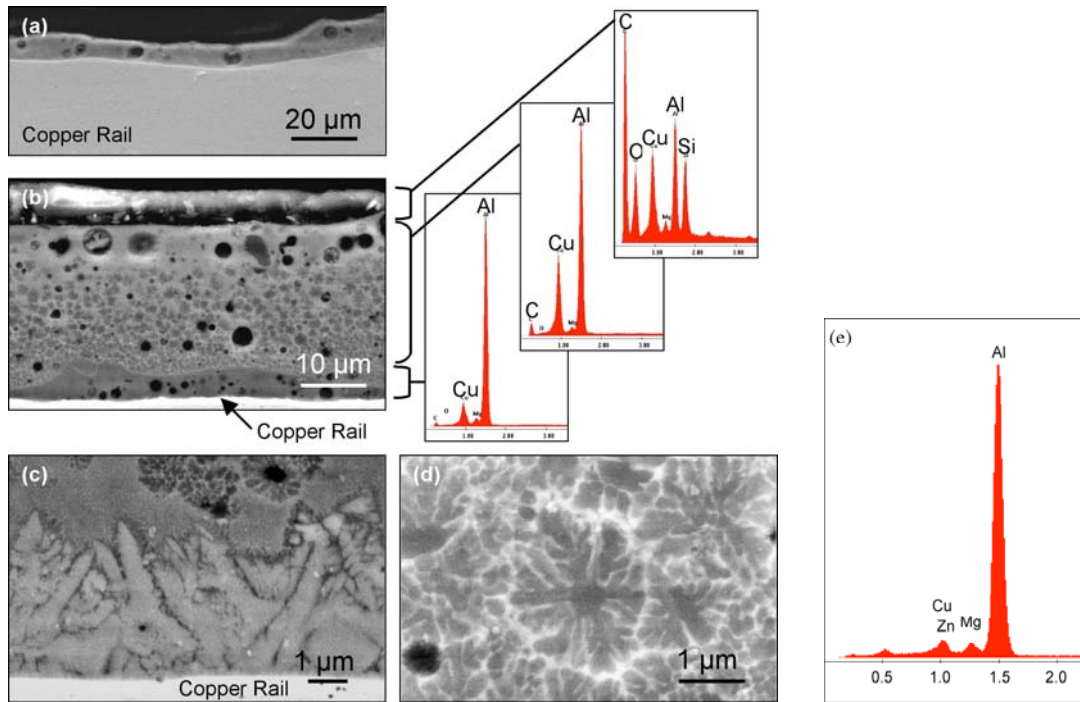
Fig. 6. SEM micrographs of deposit in the top half of 1-shot 36 cm rail sample. (a) Deposit in groove. (b) Multi-layer deposit in thick portion with EDS spectra of each layer. (c) Rail-deposit interface showing Cu-rich dendrites. (d) Cellular-dendritic microstructure in deposit. (e) EDS spectrum of 7075 aluminum armature reproduced for comparison.

SEM micrographs of the deposit in the groove and thick portions in the top half of the 1-shot and 20-shot 36 cm rail samples are given in Figs. 6 and 7, respectively. The groove deposits, shown in Figs. 6(a) and 7(a), are porous and single layer. The deposits in the thick portion, shown in Figs. 6(b) and 7(b), are also porous, but multi-layer. EDS spectra of the deposit in Fig. 6(b) show that in the multi-layer deposit, the layer closest to the rail has less copper than the layer above it. For comparison, the EDS spectrum of the 7075-Al armature is shown in Fig. 6(e), which shows very little copper. Hence, the copper reflections in the deposit spectra can only be due to alloying of the deposit with copper from the rail. The topmost layer in Fig. 6(b) is carbon-rich, which may be condensation of burnt organic byproducts. In the 1-shot sample, the rail-deposit interface, Fig. 6(c), shows copper-rich dendrites growing into the deposit. A high magnification view, Fig. 6(d), of the middle layer in Fig. 6(b) shows a microstructure of Al-rich cellular-dendrites and inter-cellular Al_2Cu . In the 20-shot sample, all three layers in the deposit, Fig. 7(b), have cellular-dendritic microstructures, but of varying scale. With large pores and fine microstructure, the topmost layer is very similar in appearance to the deposit in the groove.

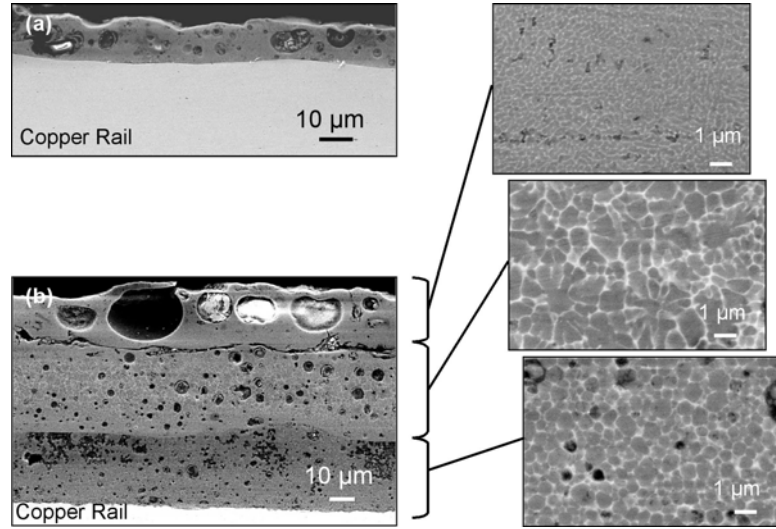
Fig. 7. SEM micrographs of deposit in the top half of 20-shot 36 cm rail sample. (a) Deposit in groove. (b) Multi-layer deposit in thick portion with microstructural detail in each layer.

Multiple shots in the 20-shot 36 cm sample result in multi-layering in the deposit. The differences in microstructural scale between layers are due to differences in solidification rates. The topmost layer has the finest microstructure and must have quenched most rapidly, the middle layer may have coarsened due to reheating. The observed two aluminum-rich layers in the 1-shot 36 cm sample are obviously not due to multiple shots. From the wavy nature of the layer closest to the rail surface and the fact that the two layers have different copper contents, it is likely that overlapping fluid flow patterns in the wake of the single shot may have occurred and resulted in the two apparent layers. The second layer is richer in copper and may have been dragged in from the groove region. The observations point to a rather complex fluid flow mechanism in railgun operation involving partial melting of the armature. The exact nature of film flow due to aerodynamic drag and surface tension effects in railguns needs to be determined and better understood.

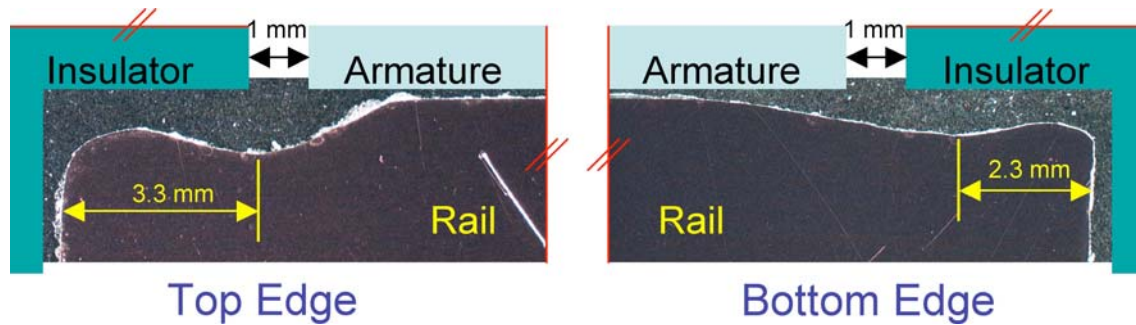
Dissolution of the copper into molten aluminum takes place as evidenced by alloying of the aluminum deposit with copper. While there is some dissolution of copper from portions of the rail adjacent to the grooves as evidenced by copper-rich dendrites at the rail-deposit interface, the most severe dissolution occurs near the rail edges where the grooves form. If one considers the measured location of the grooves and armature dimensions, most of the groove is outside the "footprint" of the armature as shown in Fig. 8. Hence, there is very little metal-to-metal contact in the groove

region, especially once the armature edges have started to erode away downstream. Plus, there is a liquid metal film, which acts as a lubricant and minimizes friction and wear. Thus the grooving cannot be related to mechanical or erosive wear from friction between the armature and rail. There may be localized scouring of the copper rail due to the presence of hard particles such as oxides in the liquid metal film, but no gross wear features of the magnitude of the grooves were observed anywhere else on the rail surface, especially where the armature was in contact with the rail.

Fig. 8. Positions of armature and insulator with respect to rail edges in 20-shot, 94 cm copper rail.
